# ANSLEY WILCOX HOUSE

## HISTORIC STRUCTURE REPORT

Theodore Roosevelt Inaugural  
National Historic Site  
Buffalo, New York

October 2006

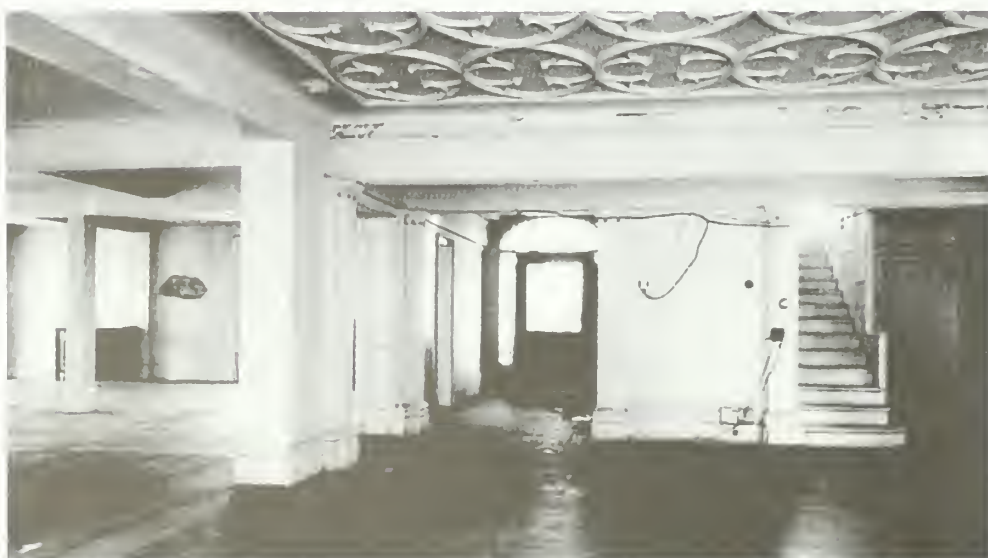
Figure 1.51. First story, looking north from Living/Morning Room, circa 1966.

Changes were less destructive within the 1896 east wing. The most extensive of these changes took place in the Living/Morning Room, where the north wall was entirely removed and a 10-foot- wide opening was cut into the west brick wall to connect to the original structure. (See Figure 1.51.) In addition, the interior partitions for the pantries were removed to create a single large kitchen. At the time of the 1938 alterations, Ethel Chapin Patch obtained two balusters from the original staircase and a bookcase from the library.<sup>29</sup> The upper portion of another bookcase was relocated to the kitchen. (See Figure 1.56.)

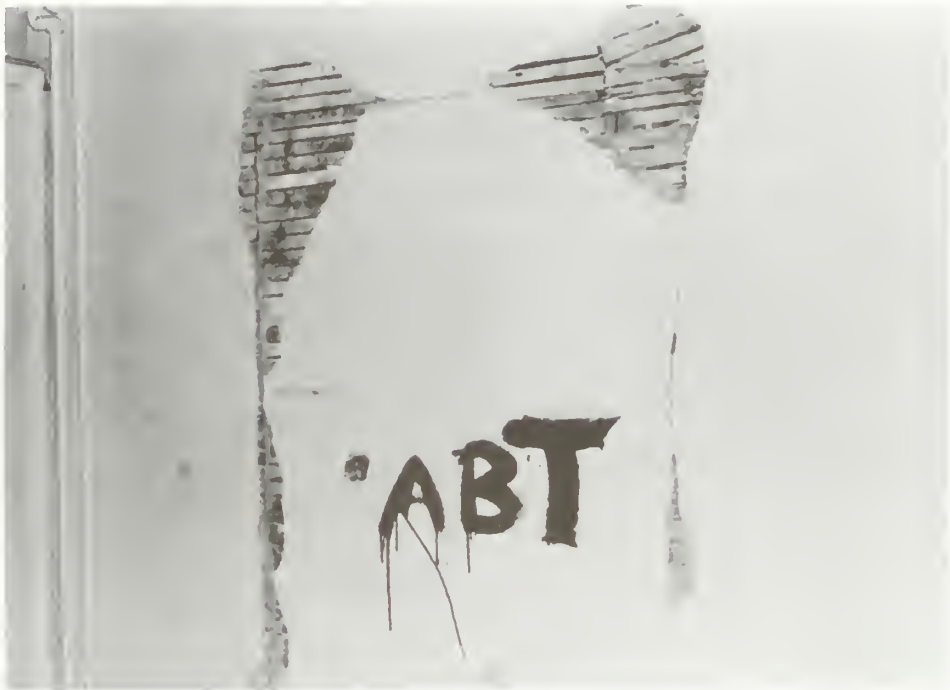
Figure 1.52. First story, closed northwest window, circa 1966.

The original building's exterior walls are three bricks thick. The interior is furred with split-board lath and plaster. As shown in historic photographs, window openings were later filled and other alterations constructed using sawn lath. (See Figure 1.52.) The brick is set in common bond with a header or tie course at every eighth course. Stone window sills are two bricks tall and project 1 inch from the face of the wall. Stone lintels are four bricks tall and set flush with the wall surface. The original bricks are 7 <sup>5</sup>/<sub>8</sub> inches long by 2 <sup>1</sup>/<sub>4</sub> inches tall.

There may have been a typical double- hung window at the southwest corner of the first story similar to the present windows N5 and N6. This is unconfirmed, but suggested by evidence of a blocked window in the same position on the north elevation. (See Figure 1.52.) The Library bay window originated between 1885 and 1889. (See Figure 2.3.) There are patches in the

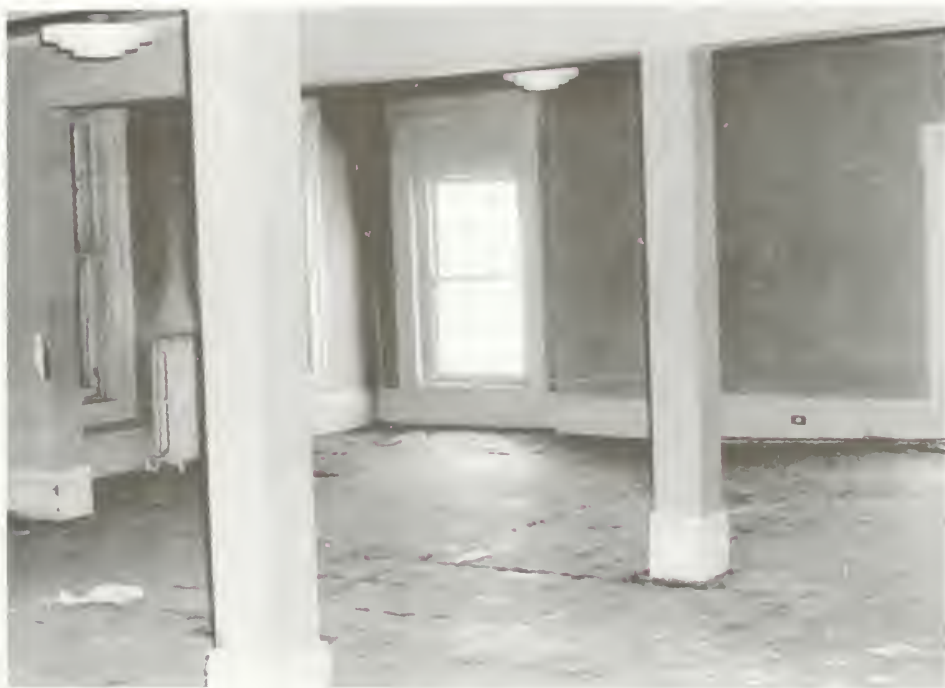
Figure 1.53. North Gallery (room 202a), as viewed from South Gallery, circa 1966.

This suggests that after the north and south exterior walls were no longer covered by the temporary one- story barracks buildings, four new windows were uniformly spaced on each wall flanking the fireplaces. It is not clear whether these windows were introduced by Laning or Joseph Masten, or whether they were features of the pre- 1839 construction. Interior doorway and window trim throughout the first story, consisting of mitered ogee (cyma reversa) moldings and plinth blocks, was probably introduced during this period. (See Figures 2.30 and 2.31.) On the second story, however, it is possible that Greek or Egyptian Revival- style shouldered architrave trim was retained from an earlier period on the new tall west windows. (See Figures 1.53 and 1.54.)

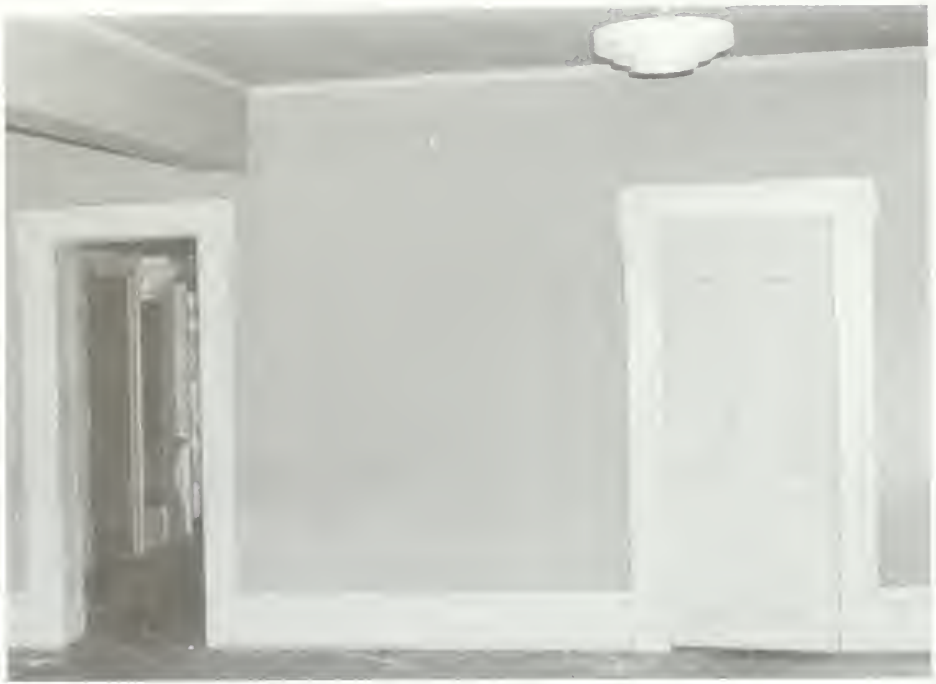
Figure 1.54. South Gallery (room 202c), east wall, circa 1966.

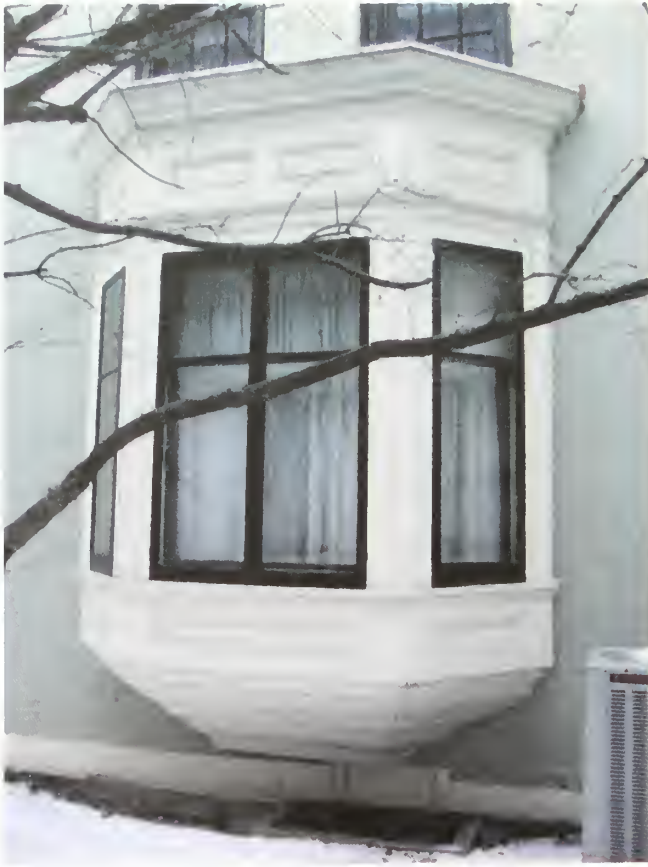
Figure 2.3. South elevation,  
ca.- 1885 Library bay  
window.

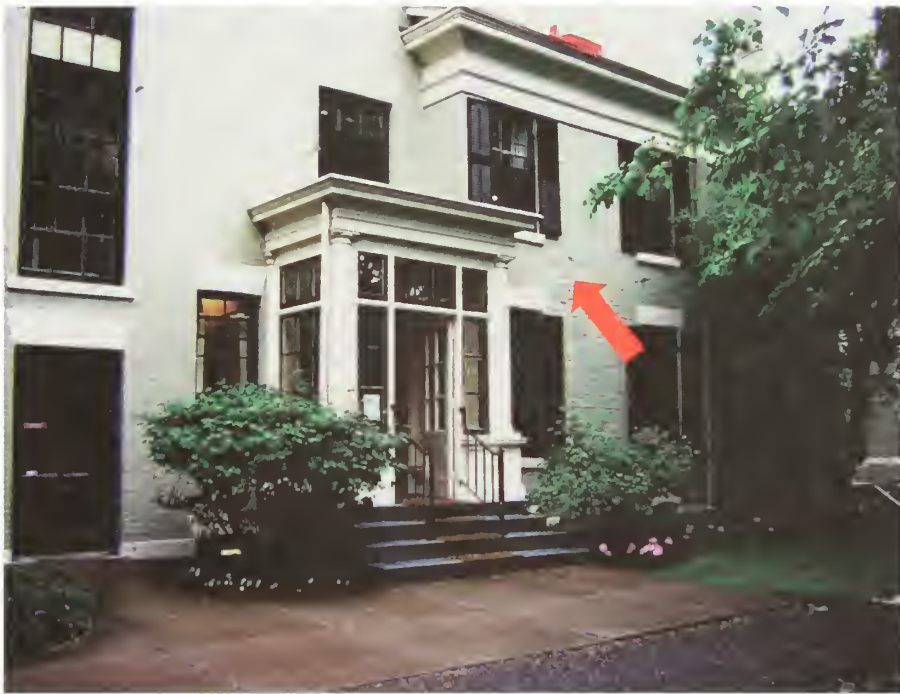
Like the south elevation, the north elevation retains evidence of its development prior to the date of the Roosevelt inauguration, as well as a number of post- 1901 alterations. There are scars in the brickwork that suggest where the roof of the temporary barracks building may have abutted the elevation during the military occupancy. (See Figures 2.13 and 2.14.) Unlike the south elevation, however, there is only one historic photograph illustrating this elevation prior to 1906. (See Figure 1.23.) This photograph shows the five present windows on the original building. The origin of these windows and their relation to the temporary barracks building that abutted the wall is unclear. In addition, a 1966 interior photograph shows a blocked window at the northwest corner of the first story. (See Figure 1.52.) The window opening in this location was shown filled with sawn lath, while the surrounding walls were sheathed with split- board lath, suggesting that the opening may be as early as 1835- 1840. Similar to the south chimneys, the two north chimneys on the original building are missing their terra- cotta caps and have iron braces.

Figure 2.13. North elevation, location of brickwork scars from formerly attached barracks building.

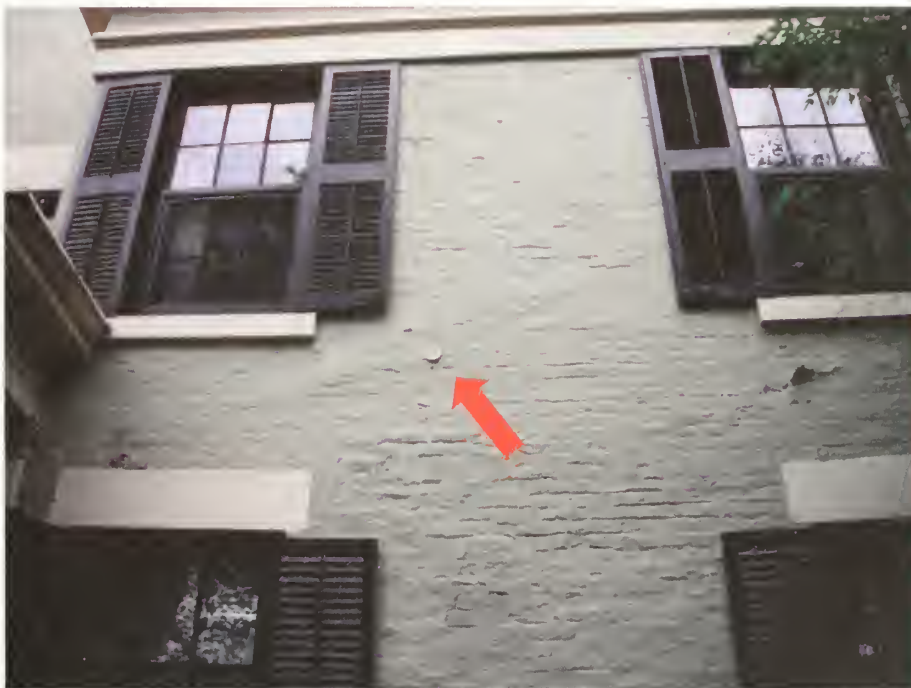
Figure 2.14. North elevation, detail of brickwork scars from formerly attached barracks building.

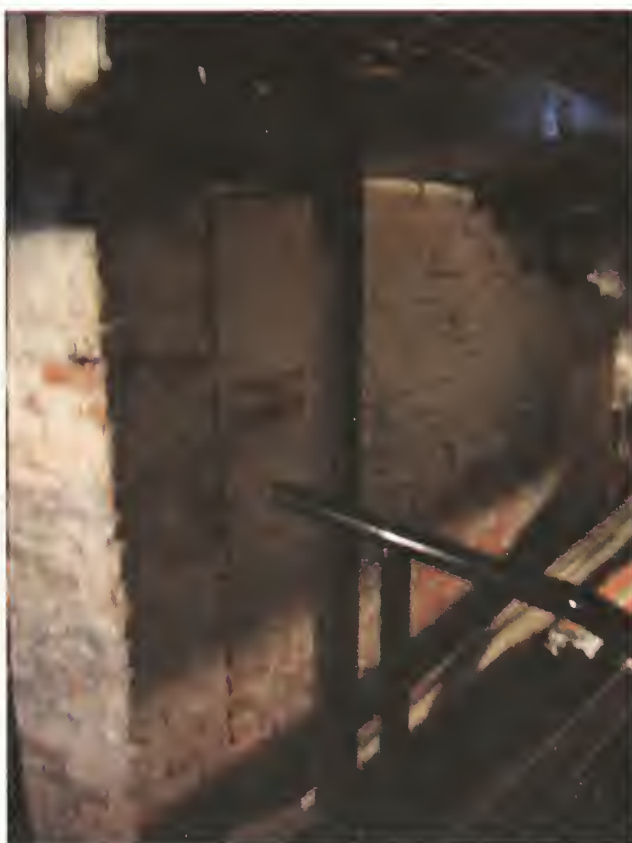
Though not mentioned in any documentation, the remains of a brick chamber extant in the center of the basement suggest that Laning altered a pre- existing brick furnace chamber to accommodate a larger furnace for an expanded central heating system. This would have served the existing house and the new rear addition, with feed and clean- out openings on the east wall facing the new basement stairway. (See Figures 1.57 and 2.23- 2.27.)

Figure 2.23. Room 001, view of unstable west wall of room 001a (central brick furnace chamber).

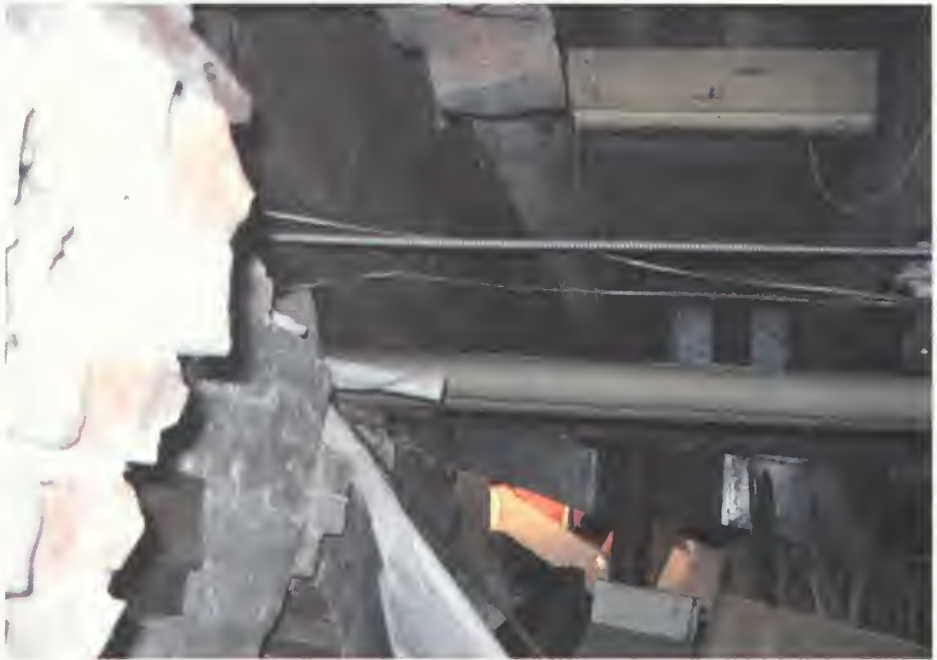
The first-floor framing is exposed. However, there are cut nails protruding from the underside of floor joists, suggesting that there was previously a plaster ceiling in the chamber. (See Figure 2.24.)

Figure 2.24. Room 001a (central brick furnace chamber), interior.

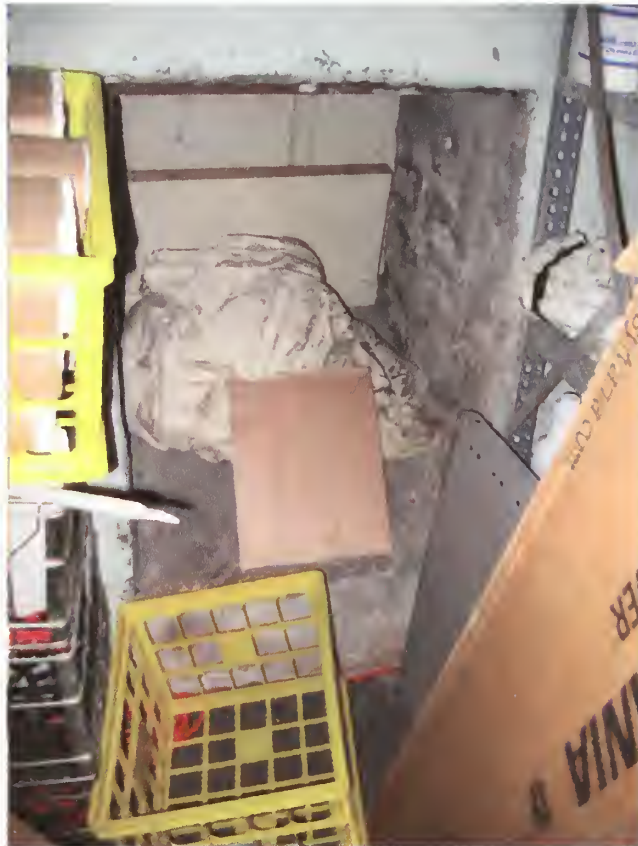
Figure 2.27. Room 001c (areaway below west portico), showing brick infill and casement window at former doorway opening.

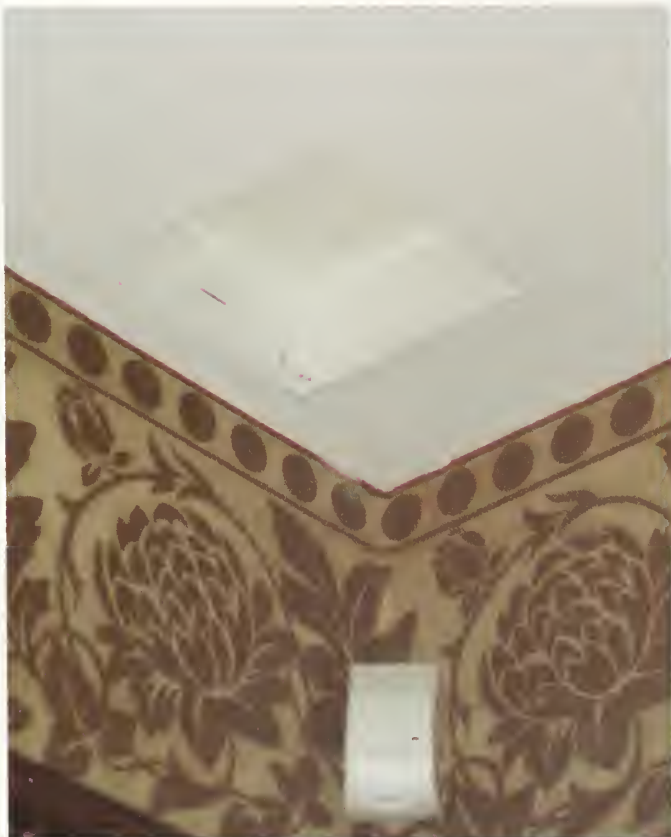
Figure 2.37. Room 104  
(Library), post- 1935 ceiling  
opening.

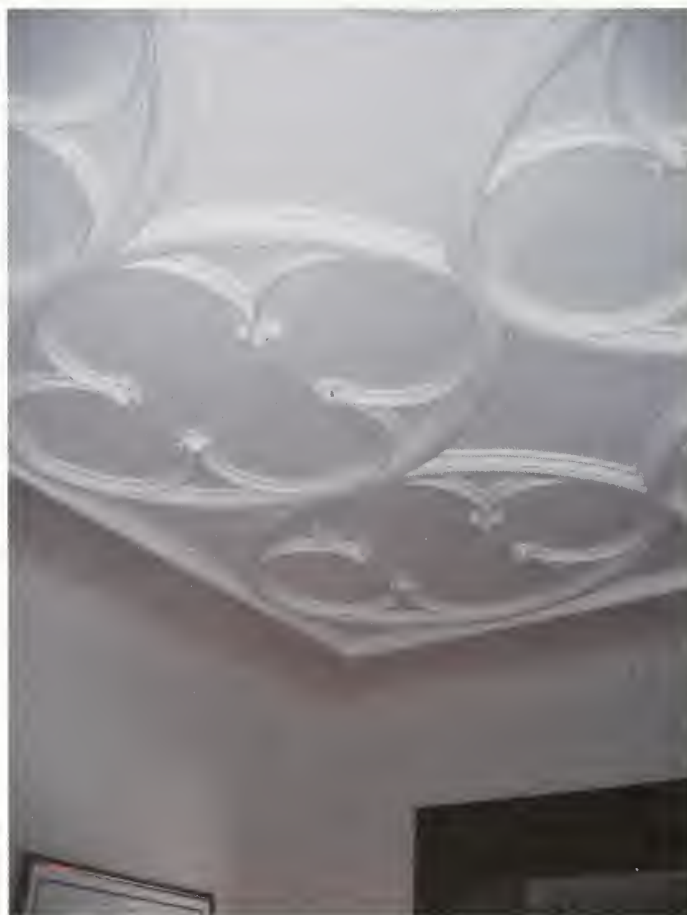
The 1896 coved plaster ceiling remains. The flat center of the ceiling is decorated with molded plaster ribs in an overall pattern of quatrefoil and lozenge shaped cells. (See Figure 2.41.)

Figure 2.41. Room 107 (Living Room), ceiling.

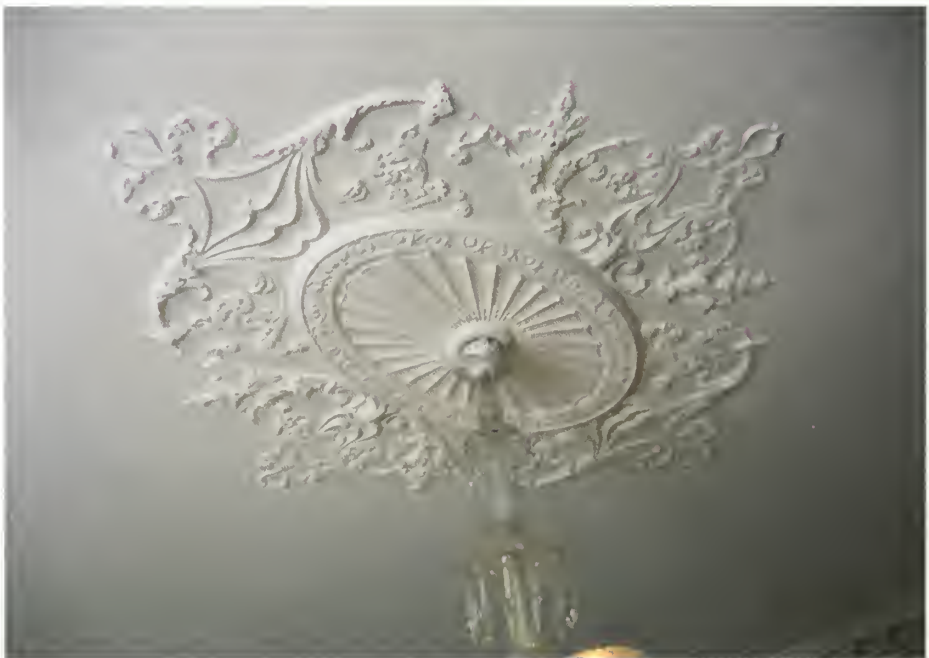
The 1896 plaster ceiling with elliptical sunburst medallion and plaster relief ornament remains intact. During the restaurant occupancy, acoustic tile was adhered around the medallion. These tiles were removed in 1971. (See Figure 2.45.)

Figure 2.45. Room 108 (Dining Room), ceiling medallion.

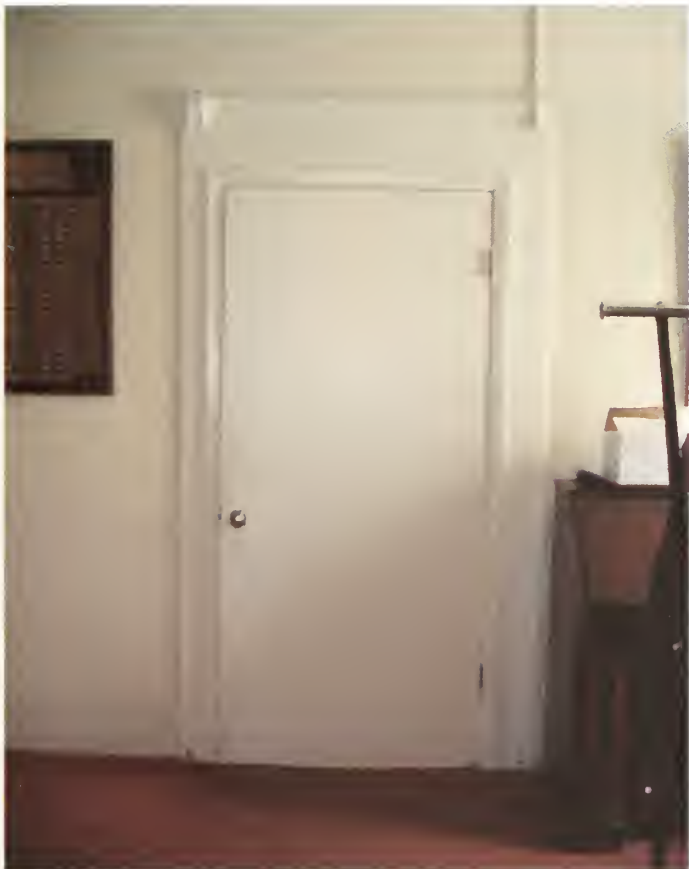
The north wall contains an 1896 window opening that was converted to a doorway in 1938 to access the north addition. A new lintel was inserted below the 1896 flat brick arch, the opening was made narrower, and a modern flush wood door was installed. (See Figure 2.46.) Portions of the original window's molded casing remain.

Figure 2.46. Room 112 (Kitchen), north wall, 1896 window opening converted to doorway.

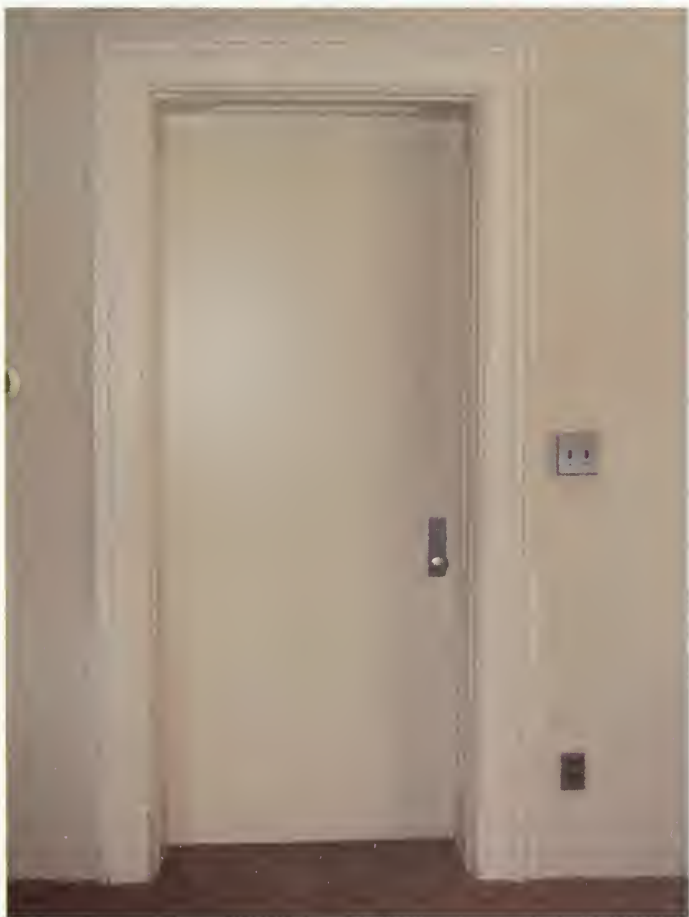
The west wall retains its 1896 cased doorway to the former Servant's Hall (now room 109), complete with original casing and paneled wood jambs. Also visible are remnants of the wood wainscot that formerly surrounded the doorway. A modern flush door was installed in 1971. (See Figure 2.47.)

Figure 2.47. Kitchen (room 112), west doorway and wainscot remnants.

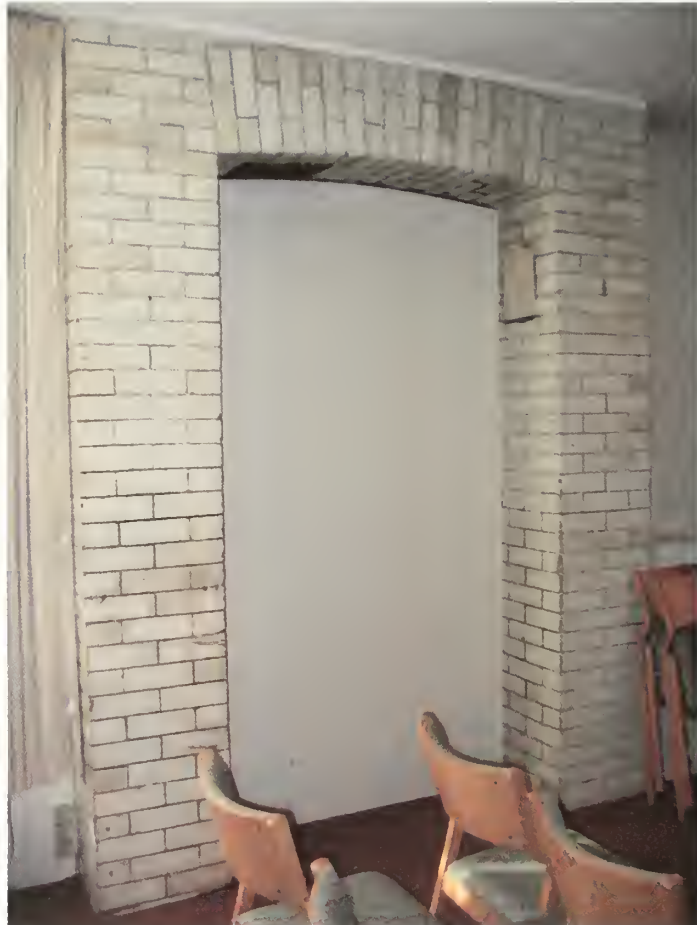
On the east wall is the 1896 Kitchen fireplace, a prominent feature constructed of "enameled" or glazed brick with a broad segmental brick arched firebox opening. The bricks measure  $8\frac{3}{4}$  by  $2\frac{1}{4}$  by  $4\frac{1}{2}$  inches. (See Figure 2.48.) To the left of the fireplace is an 1896 window with 1896 wood casings. To the right of the fireplace is an 1896 doorway with 1896 casings, a paneled wood door, and remnants of the 1896 wainscot and dado cap that formerly surrounded the doorway.

Figure 2.48. Room 112 (Kitchen), fireplace.

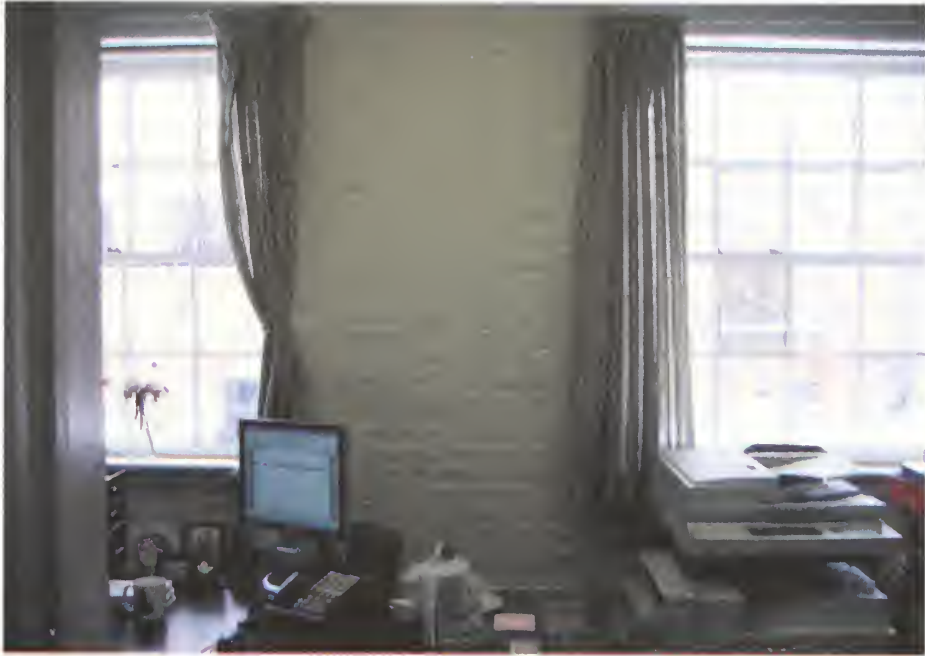
The north wall of the 1938 addition incorporates approximately 80 per cent of the two-story south wall of a former carriage house associated with the property (i.e., 37 feet of the original 46-foot-long wall). When the ca.- 1875 carriage house was demolished in 1938, this wall fragment was retained and incorporated into the addition. The exterior face of the wall fragment presently faces the interior of the addition. The wall was originally three bricks thick. Its original exterior face brick is visible in Rooms 113 and 115; individual bricks measure  $7\frac{5}{8}$  inches long by  $2\frac{1}{4}$  inches tall. (See Figures 2.49 and 2.50.) By comparison, the 1896 face bricks measure  $8\frac{1}{2}$  inches long by  $2\frac{1}{2}$  inches tall. In 1938, original doorway and window openings were filled with brick, and new openings were cut through the wall. (See Figures 1.35, 2.12, 2.49, and 2.50.) The original interior surface of the wall fragment presently faces the exterior and is covered by a veneer of 1938 face brick.

Figure 2.49. Room 113 in the 1938 addition, north wall, brick exterior wall of former carriage house.

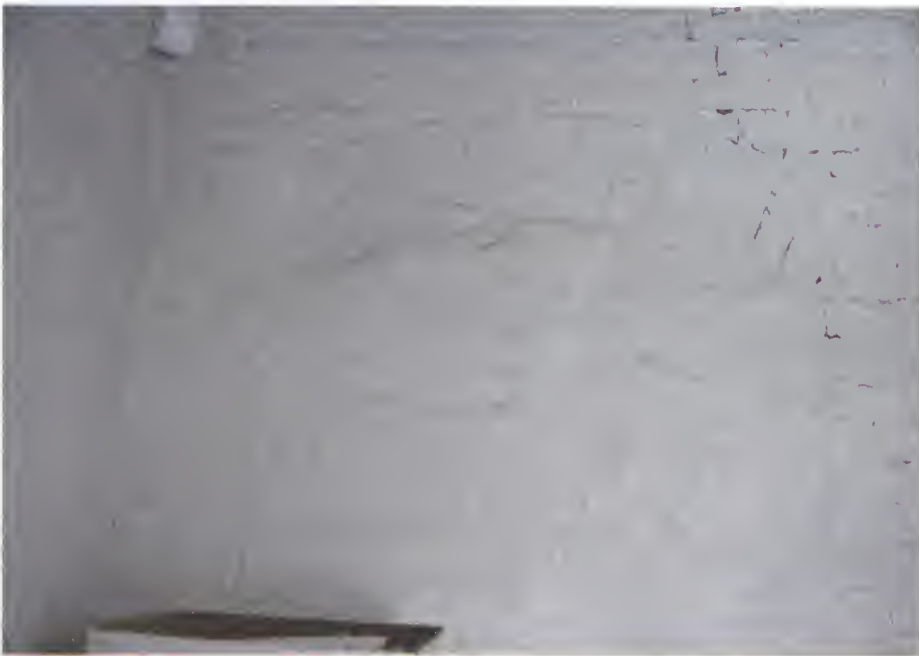
Figure 2.50. Room 115 in the 1938 addition, north wall, infilled arched window opening in brick wall of former carriage house.

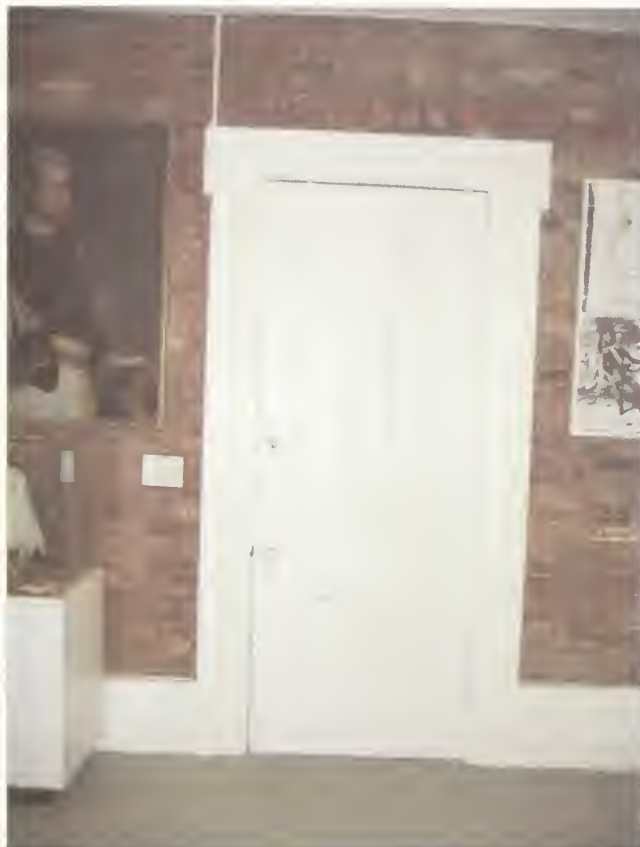
This doorway is the remnant of a doorway between the original stair hall and the second- story hall in the 1896 addition (room 203). In 1896, this was a wide opening with a soffit supported on ornamented console brackets. (See Appendix B.) The iron lintel for this opening is still visible in Room 203. (See Figure 2.54.) By 1938, the wide opening was partially filled with brick and reduced to the present doorway.

Figure 2.54. Room 203  
(Second- Story Back Hall),  
west wall, pre- 1938 doorway  
and brick infill.

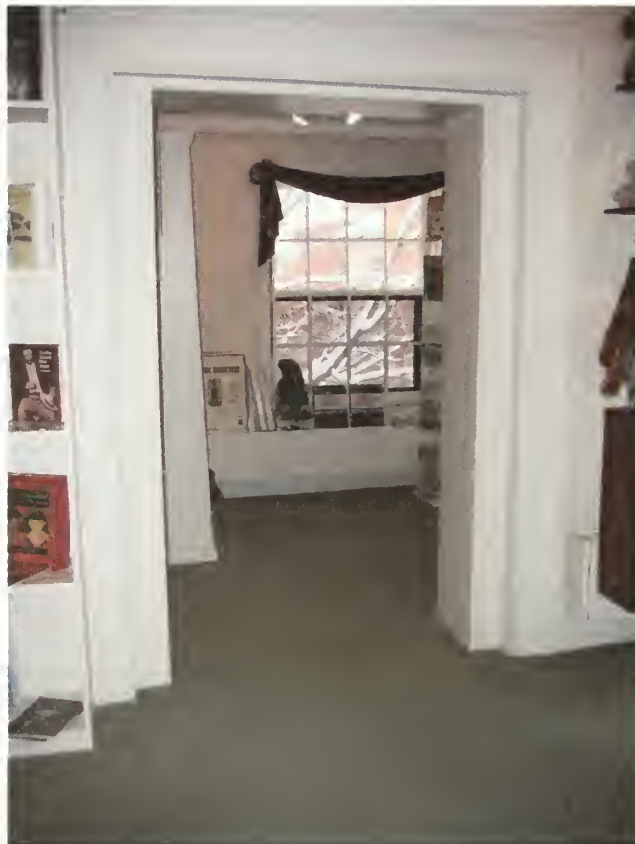
Figure 2.65. Room 208, north wall, 1896 window converted to doorway in 1938.

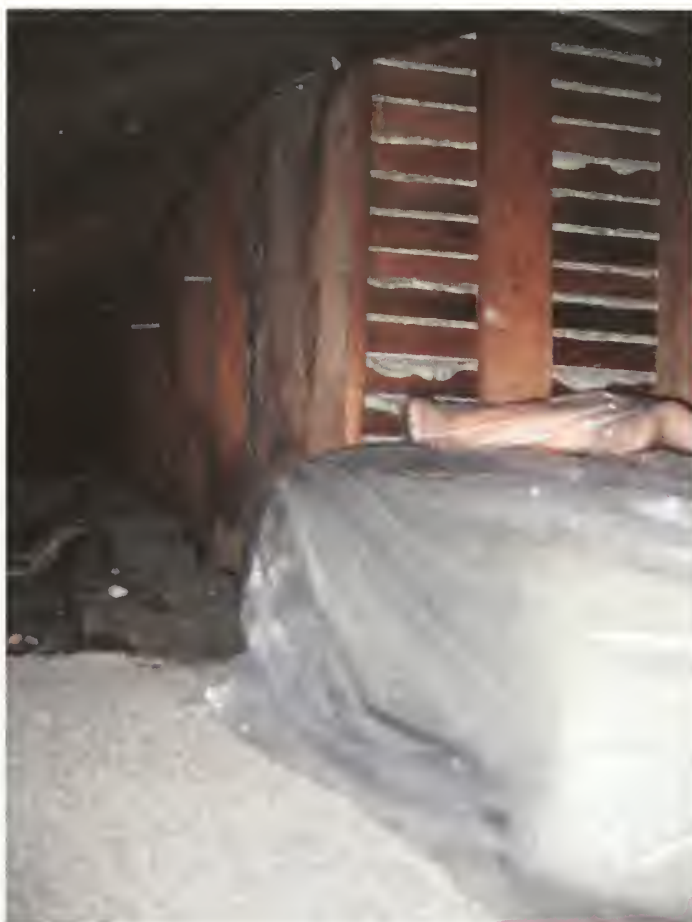
The west wall is formed by the back sides of the dormer in room 309 and that room's closet (309a). It can be seen that the frame partitions of the dormer and the closet walls consist entirely of sawn lumber and sawn wood lath, indicating a later period of construction than the knee walls, probably dating to the Wilcox occupancy. (See Figure 2.71.)

Figure 2.71. Room 308a, looking west toward dormer cheek wall.

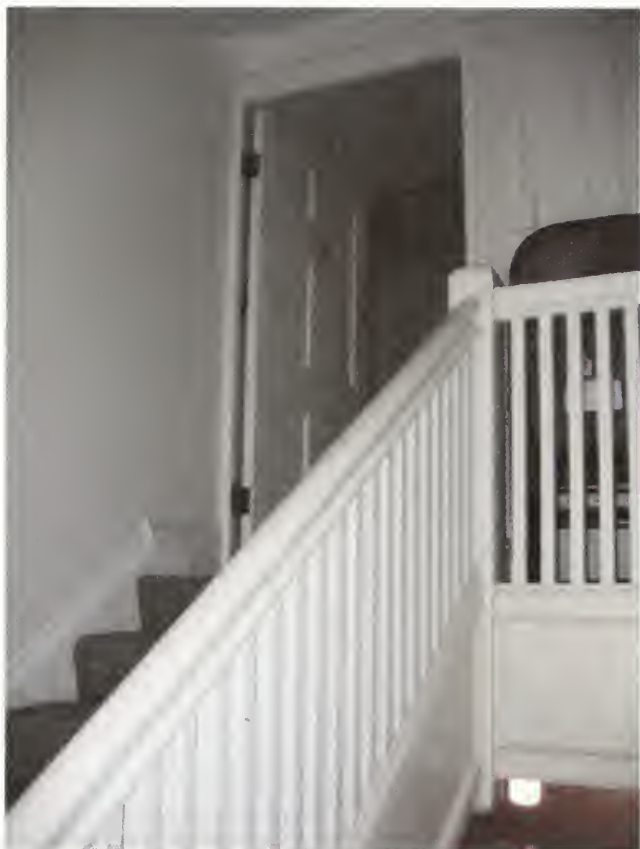
The east and west walls are 1896 frame partitions with lath and plaster finish. There are 8- inch- high molded baseboards on the east wall, and 9 ½- inch- high baseboards with a more complex molded profile on the west wall descending to the second story. No attempt was made to align and miter the sloped baseboard on the staircase with the level baseboard on the landings. This fact underscores the room's utilitarian character. (See Figures 2.72 and 2.73.)

**Figure 2.72.** Room 301  
(North Staircase).

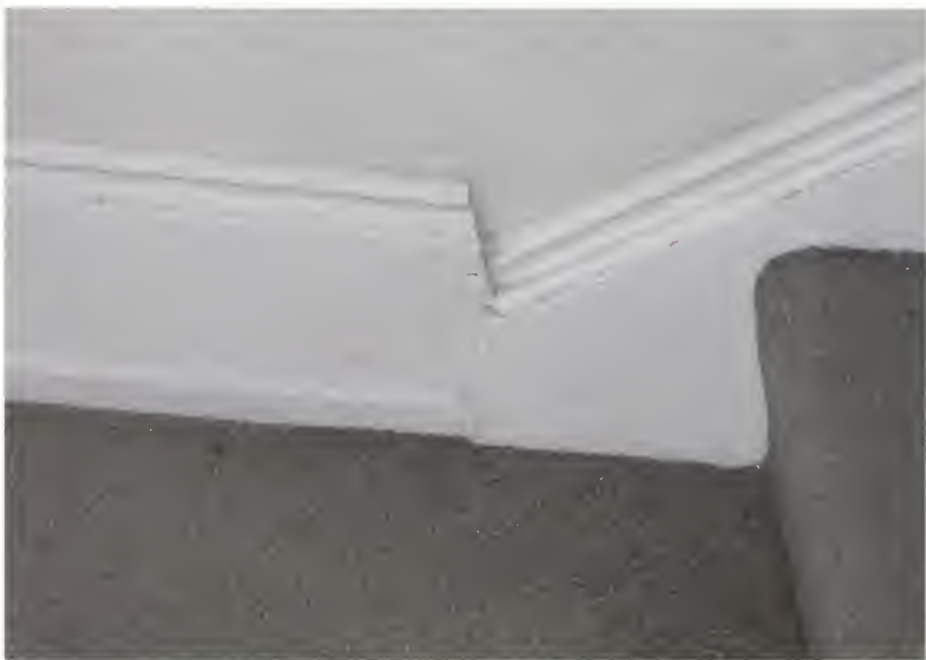
The inside stair stringer is raised above the tread nosings, and supports the balusters and handrail. The balustrade consists of newel posts 4 ¾ inches square at each landing, with a molded hand rail measuring 3 ¾ inches spanning between the newels. Balusters are 1¾ inches square and 3 inches on center. (See Figure 2.73.)

**Figure 2.73.** Room 301 (North Staircase), baseboard.

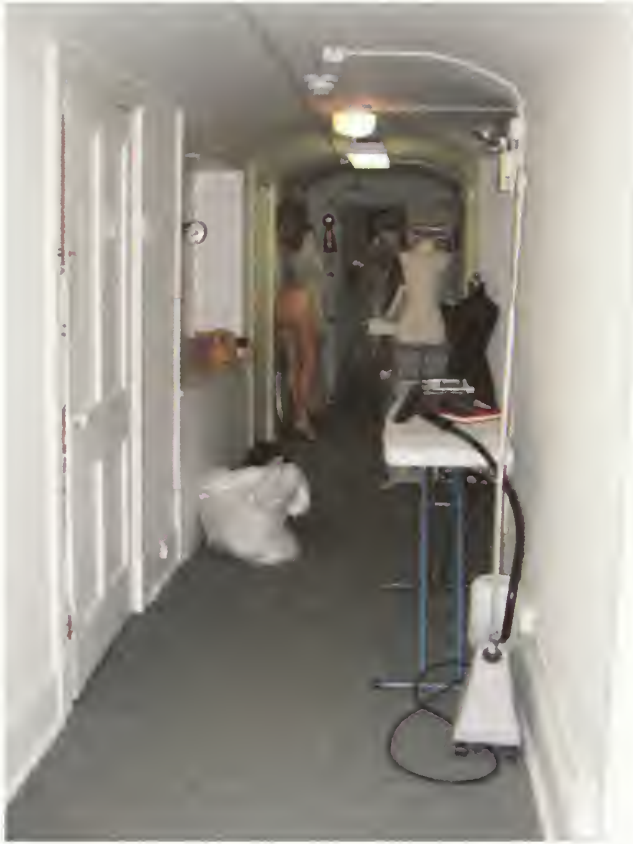
Room 302 is shown on the 1896 architectural drawings, and it remains as originally designed. (See Figure 2.74.)

Figure 2.74.  
Room 302 (Hall).

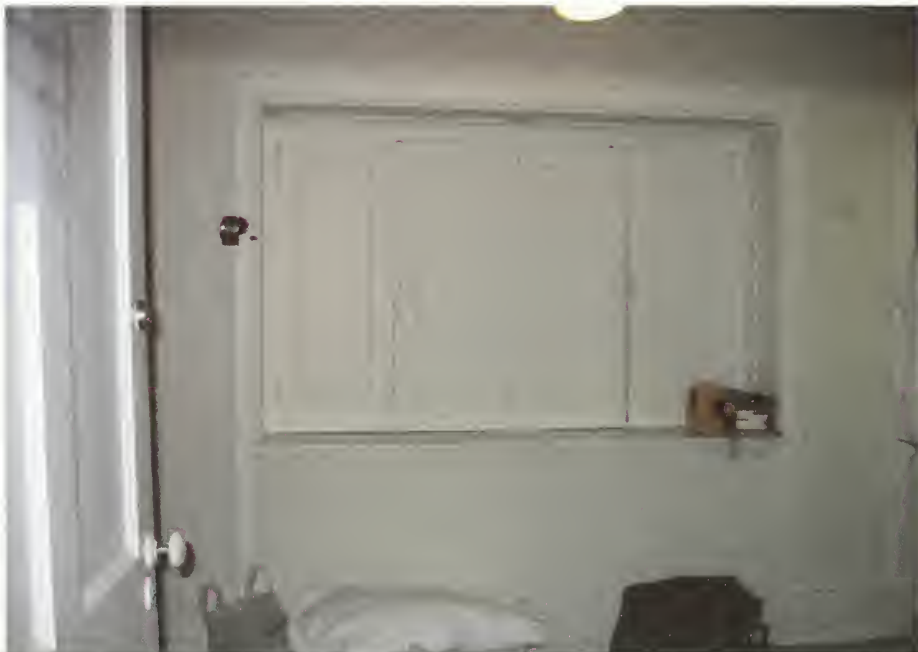
Opposite the staircase is a linen closet recessed into the south wall. (See Figure 2.75.) This closet consists of two compartments, each enclosed by a pair of paneled wood doors and lined with double- beaded cedar boards 5 inches wide. There are two wood shelves in each compartment. Below the doors is a plywood panel, where drawers were probably originally located. (See the description of the built- in cabinet in room 306.).

Figure 2.75. Room 302 (Hall), south- wall linen closet.

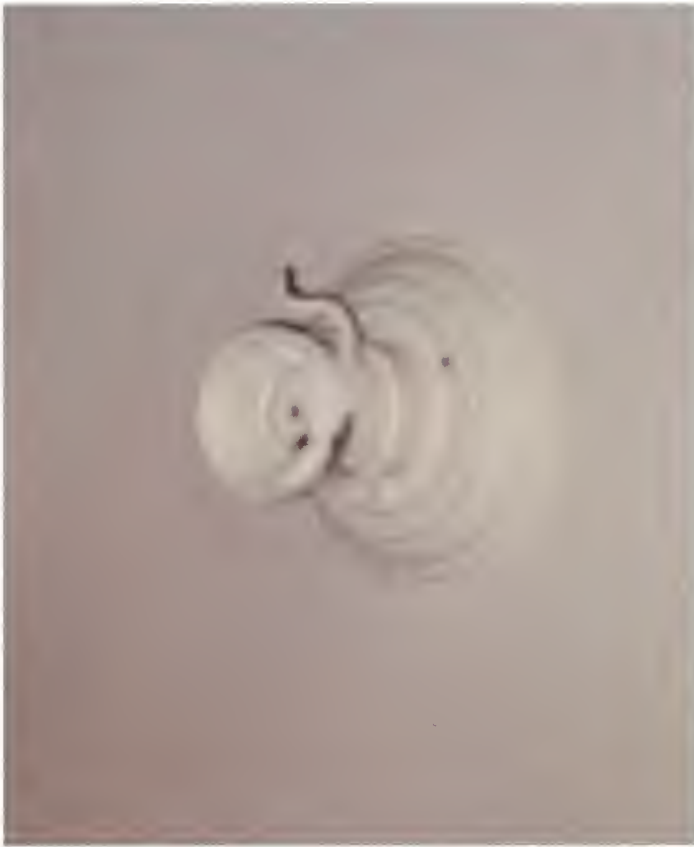
At the east end of the south wall is a speaking tube and spun- metal whistle piece. (See Figure 2.76.) According to the 1896 specifications, speaking- tube communication was provided between the first- story Kitchen and the third- story servants' hall. The whistle piece has been crushed by the swing of the door to room 305. A turned wood doorstop is mounted on the baseboard below, and was probably added after the damage. (See Figure 2.77.) It is identical to the doorstop at the doorway to the North Staircase (room 301).

**Figure 2.76.** Room 302 (Hall), wall- mounted speaking- tube fixture.

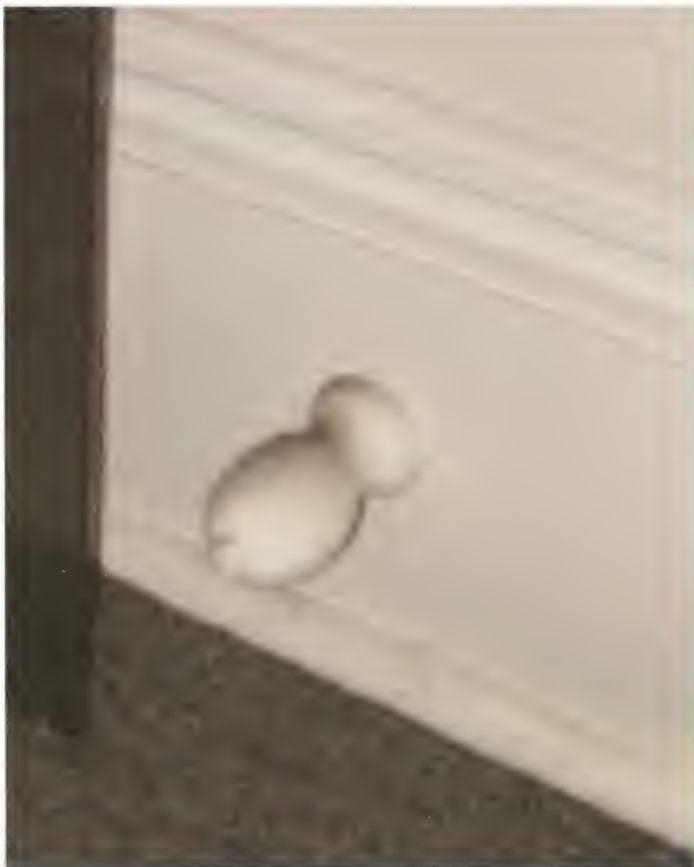
**Figure 2.77.** Room 302 (Hall), doorstop below speaking- tube fixture.

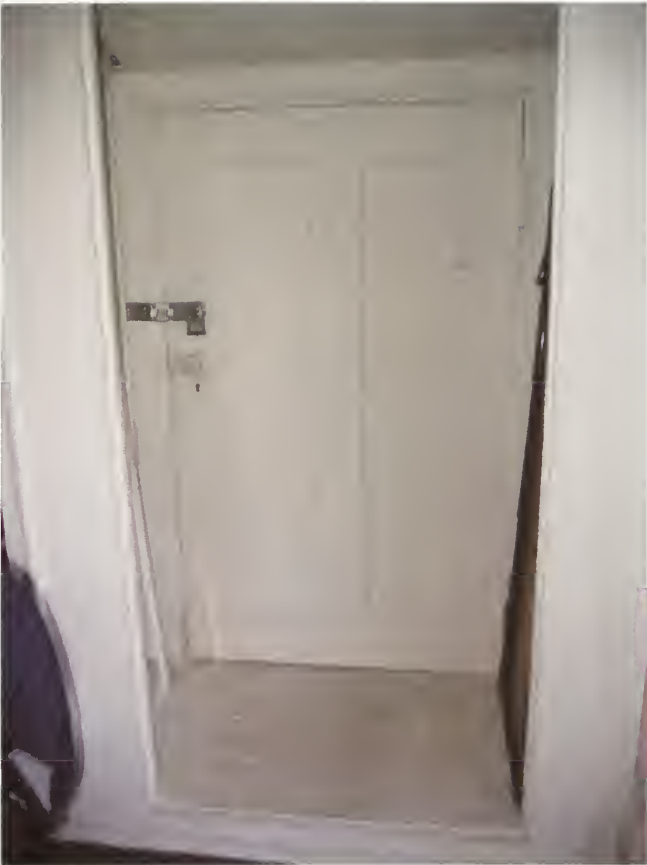
Doorway and window casings are plain boards with mitered corners and molded edges; doorway casings also have plinth blocks. The door to room 305a is a two- panel wood door situated at the back of the northeast closet. (See Figure 2.78.) The door to room 305b is a plywood panel; the doorway's casing is missing.

Figure 2.78. Room 305,  
northeast closet containing  
doorway to room 305a.

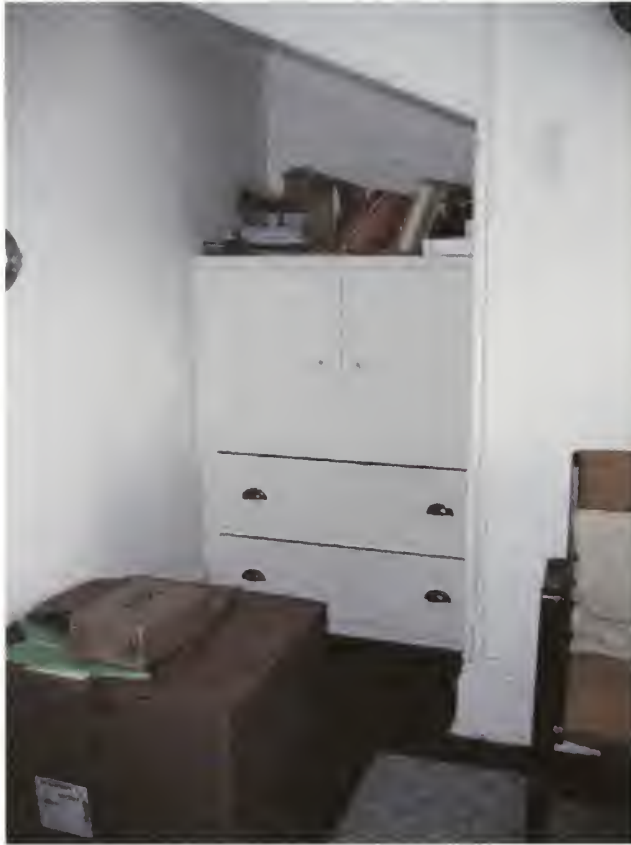
In the northeast corner of the room (anteroom) there is a recess containing a built- in wood cabinet. The edges of this recess are covered by wood corner guards with ornamental turnings. The cabinet front consists of a pair of flush doors and two drawers with metal pulls. The pair of doors probably replaced two additional drawers. To the right of the cabinet (also in the anteroom space) is an oval wall bracket for a light fixture. (See Figures 2.80 and 2.81.)

**Figure 2.80.** Room 306, recess with built- in wood cabinet.

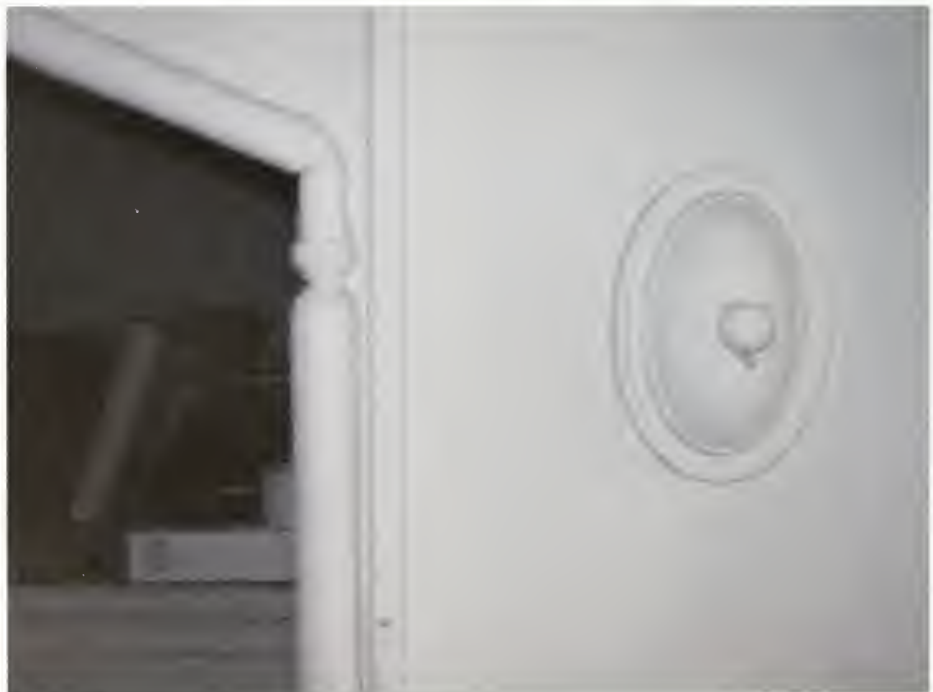
**Figure 2.81.** Room 306, wood corner guard on edge of recess, and remnant of light fixture.

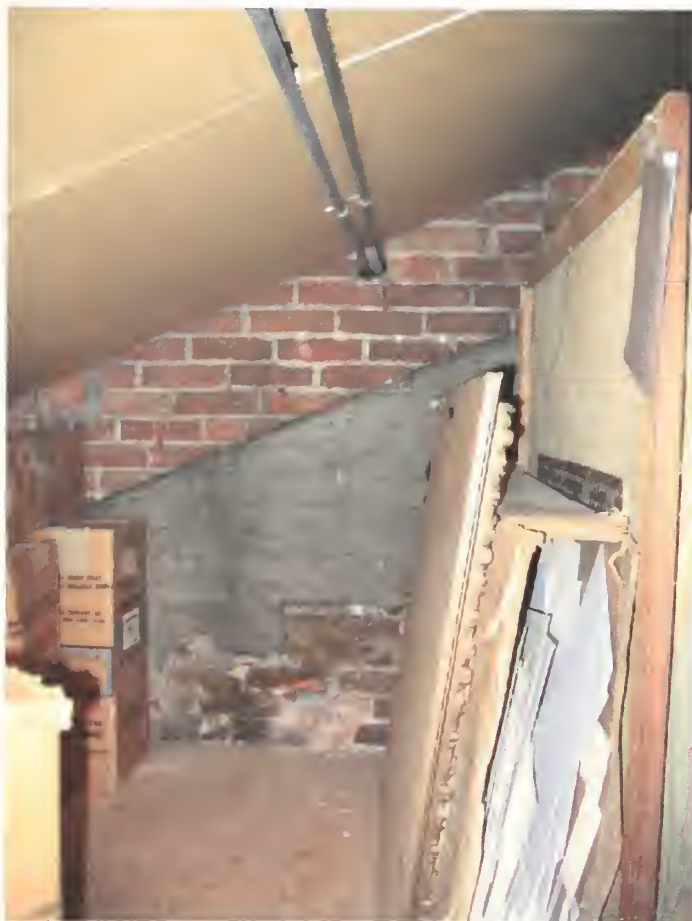
The north and east walls are unfinished frame partitions, revealing the back side of the sawn wood lath and plaster finishes in rooms 302, 302b, and 306. The west wall is the original brick gable end wall. On this wall, remnants of the stepped flashing for the roof of the 1864- 1865 addition survive. Above the flashing are multiple paint coatings that extend up to the line of the former wood frieze, now removed. (See Figure 2.82). The south wall is the 1896 brick gable end wall, which holds an ornamentally leaded lunette window. The arch of this window is formed by two rows of brick headers. The boiler room chimney passes through this room to the roof.

Figure 2.82. Room 307, looking west toward original brick gable end wall, showing roof line of 1864- 1865 addition and paint evidence.
